Damage sequence and safety margin assessment of expansion joints by shake table testing

DAMAGE SEQUENCE AND SAFETY MARGIN ASSESSMENT OF EXPANSION JOINTS BY SHAKE TABLE TESTING

SUMMARY

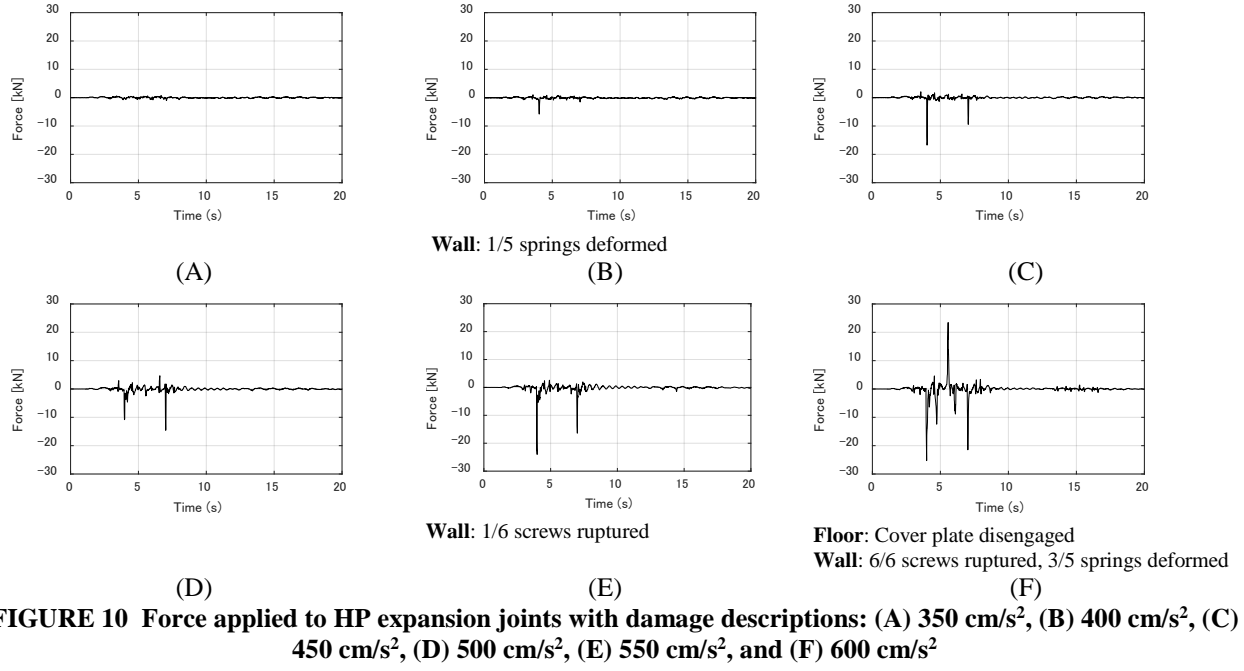
The force F_{expj} applied to the HP expansion joint specimens was derived from the above procedures. Figure 10 shows the time history of F_{expj} with damage descriptions for the specimen subject to different amplitudes of sine wave 1.0 Hz. The negative value indicates that a force was applied when the two frames approached. Note that F_{expj} is the total force applied to the floor and wall expansion joint specimens. At first, during the input of the 350 cm/s² excitation, no force was observed on the expansion joints, which validated the smooth movement of the expansion joint specimen. Under 400 cm/s², damage occurred at one of the five springs of the HP wall expansion joint specimen. This could be related to the peak force in the negative side. From 450 cm/s² and beyond, the two steel frames collided repeatedly, and the resulting force increased as the input amplitude increased. Under 550 cm/s², approximately -25 kN was observed at the first collision, which resulted in the fracture of one of

the six screws. After 600 cm/s², all six screws and two other springs at the HP wall expansion joint specimen were broken. The cover plate of the HP floor expansion joint specimen was also disengaged when the two frames moved away from each other.

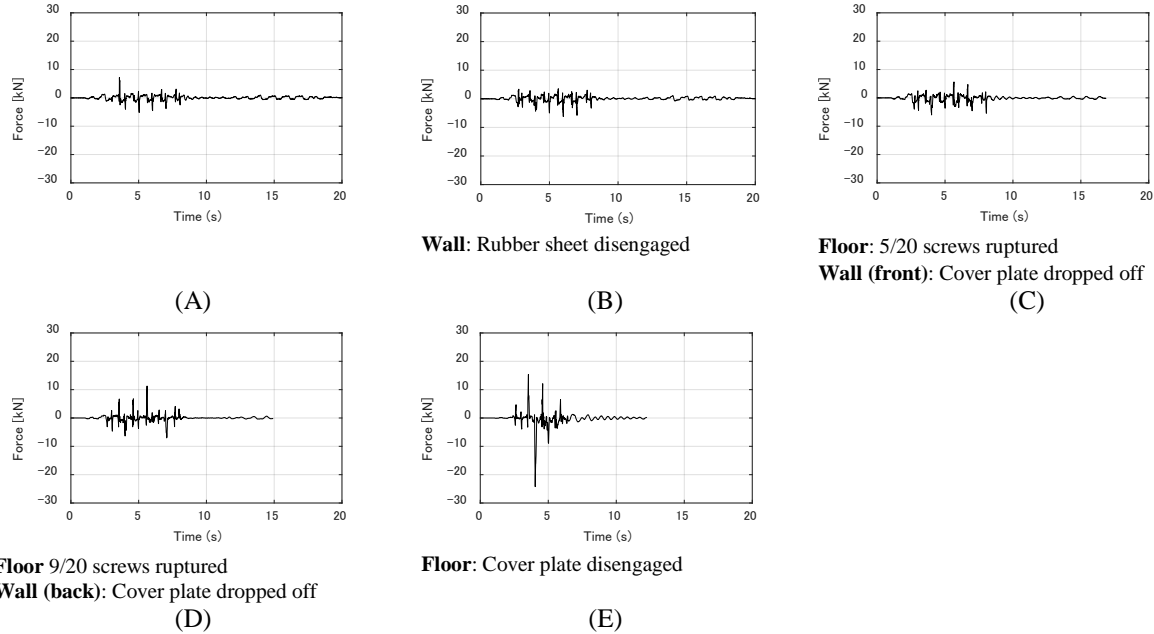
Figure 11 illustrates the time history of F_{expj} for the SD floor and wall expansion joints with damage descriptions. In general, F_{expj} was smaller for the SD specimens than for the HP specimens because the two frames connected with the SD expansion joint specimens did not experience a collision. Several peaks of small forces were observed due to collisions between the cover plate and the screws of the SD floor expansion joint specimens. Even though the cover plate of the SD wall expansion joint specimens fell off under the 450 cm/s² and 500 cm/s² excitations, a large force did not appear. This was because the sliders of the SD wall expansion joint specimens railed off smoothly. Under 550 cm/s², the large negative force was observed because the cover plate of the SD floor expansion joint specimen collided with the side plates. The large positive force appeared when the cover plate of the SD floor expansion joint was disengaged.

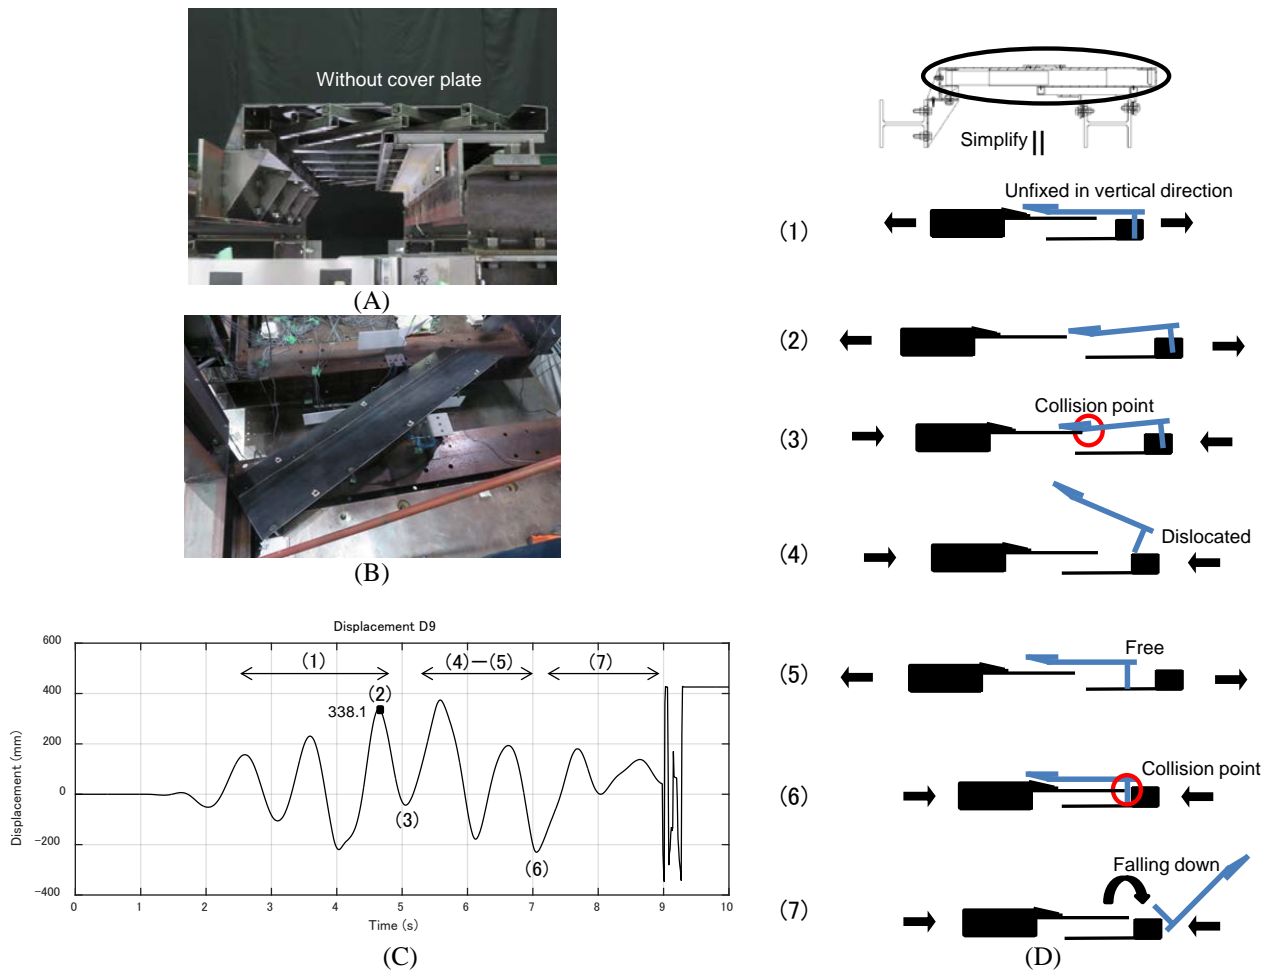
FIGURE 12 HP floor specimen DS1 (cover plate disengaged): (A) after cover plate disengagement, (B) dropped cover plate, (C) relative displacement during input of 600 cm/s², and (D) descriptions of damage sequence

The first damage pattern observed for the HP floor expansion joint was cover plate disengagement during the input of 600 cm/s², as shown in Figure 12(A)-(B). Figure 12(C) shows the relative displacement corresponding to each condition described in Figure 12(D). Based on Figure 12(D) and videos, the relative displacement in the tension side immediately before the collision, noted as (2), was 33.8 cm. At this deformation, the plate underneath the cover plate could no longer support the cover plate. As a result, the cover plate was inclined to the inner side, and the collision (3) occurred. After the collision (3), the cover plate was dislocated from the holes, noted as (4), and freely stood (5). Then, the two frames approached the relative displacement of 23.0 cm, and the collision (6) occurred. Finally, the cover plate fell off and disrupted the displacement sensor D9 (7). This damage was induced by the two collisions at (3) and (6) in Figure 12(D), and these collisions caused the large peak accelerations in Figure 9 as mentioned before. The second collision did not occur without the first collision, but there is also a possibility that the cover plate fell off due to the first collision. Therefore, the first collision was considered critical, and the critical relative displacement of this damage was evaluated as 33.8 cm in the tension side. This value is 193% of the design motion range of 17.5 cm, and thus the tested HP expansion joint has a sufficient safety margin beyond the design tolerance.

This expansion joint can be reused immediately after re-engaging the cover plate according to the expansion joint manufacturer. Therefore, following the definition in Table 2, this damage was defined as damage state 1. Even though this was not a failure state, loadings were finished because the displacement response of the SSBs nearly reached the maximum capacity of 40 cm.

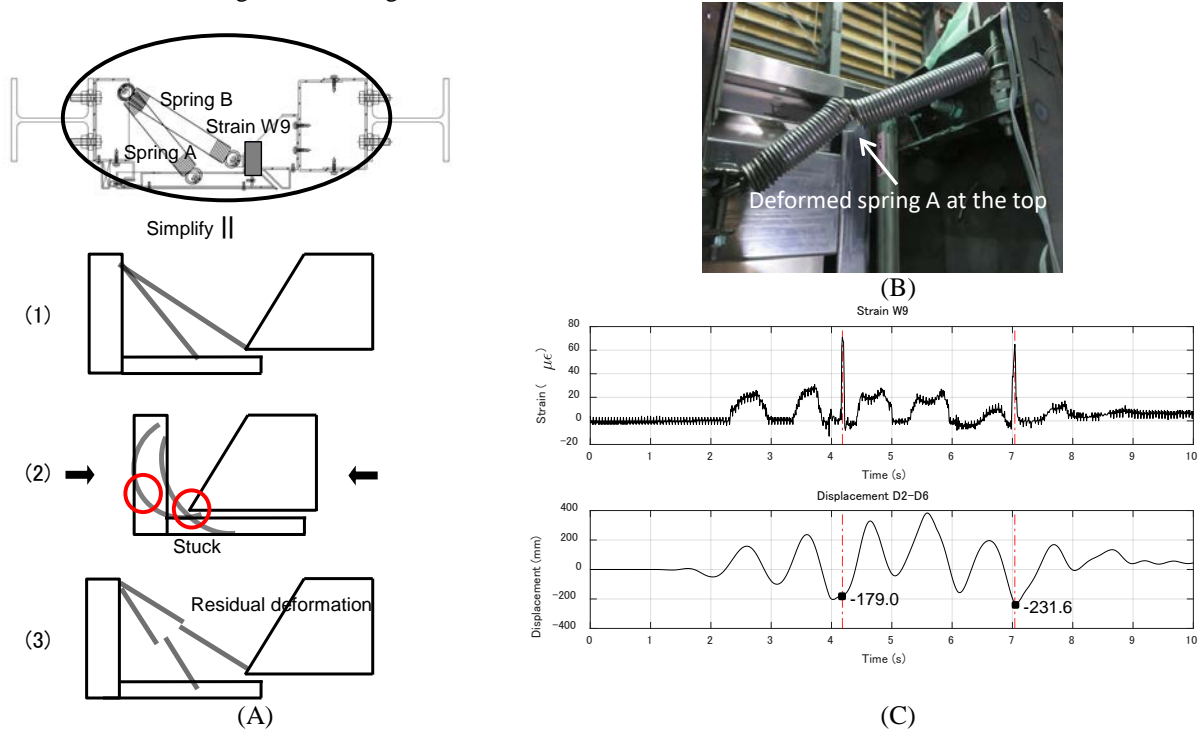
FIGURE 13 HP wall specimen DS1-A (spring deformation): (A) damage sequence, (B) residual deformation of spring A after input of 400 cm/s^2 , and (C) strain and relative displacement response during 600 cm/s^2

There were five springs (three of spring A and two of spring B in Figure 13(A) inside the HP wall expansion joint specimen. Their function was to pull back the cover plate from rotation. Excited by the sine wave of 400 cm/s², one spring A at the top was caught on a surrounding member at the time of compression, and a residual deformation remained in the spring. This was confirmed by video. Because there was no residual rotation at the cover plate, this damage was classified as damage state 1.

After the input of 600 cm/s², two spring B sustained residual deformation. Figure 13(C) shows the time history response of the strain gauge labeled W9 attached close to the base material and the relative displacement between two frames. There were two peaks in the response of strain W9, which were attributed to a collision with springs or other materials. The relative displacements at the timing of the strain peaks were 17.9 cm and 23.2 cm in the compression side. Therefore, this damage depended on the relative displacement in the compression side. The critical relative displacement of this damage was evaluated as the maximum relative displacement in the compression side, which was 23.2 cm for the input of 600 cm/s² and 19.1 cm for 400 cm/s². These values are beyond the design motion range, and the seismic performance of this expansion joint satisfied the required performance in Table 1.

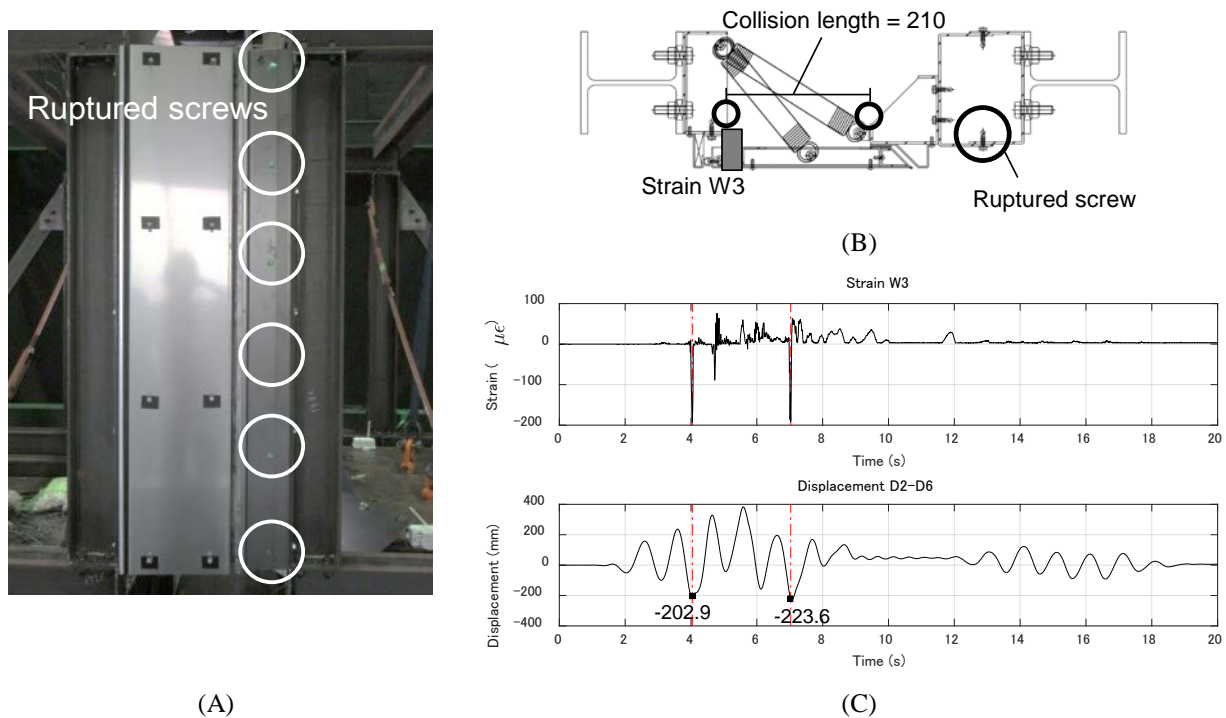
FIGURE 14 HP wall specimen DS1-B (screw rupture) (unit: mm): (A) damage location; (B) damage descriptions in the drawing, and (C) strain and relative displacement during the excitation under 600 cm/s^2

Another damage state observed for the HP wall expansion joint was the rupture of screws at the base materials as shown in Figure 14(A) and (B). The damaged screws were M6 drill screws. At the input of a sine wave of 550 cm/s², the base materials collided twice at the collision point indicated in Figure 14(B), and one of the six screws fractured. Under the input of 600 cm/s², the other five screws were also fractured. Even without screws, this expansion joint retained its function, and a small repair was required. Thus, this damage was defined as damaged state 1. Because “DS-1A: spring deformation” occurred at the same time, these damage states were classified as simultaneous damage.

construction errors. All screws were nearly fractured at the first collision, and thus a larger relative displacement of 22.4 cm was required at the second collision because the surrounding materials moved due to the loss of the screws.

Based on the above analysis, this damage state clearly depends on the relative displacement and the collision length. In summary, two patterns of damage state 1 were observed when the relative displacement was nearly equal to 110 and 130% of the design motion range. Although the experiment ended without observing the failure state, the margin of failure should be larger than 130% of the design motion range.

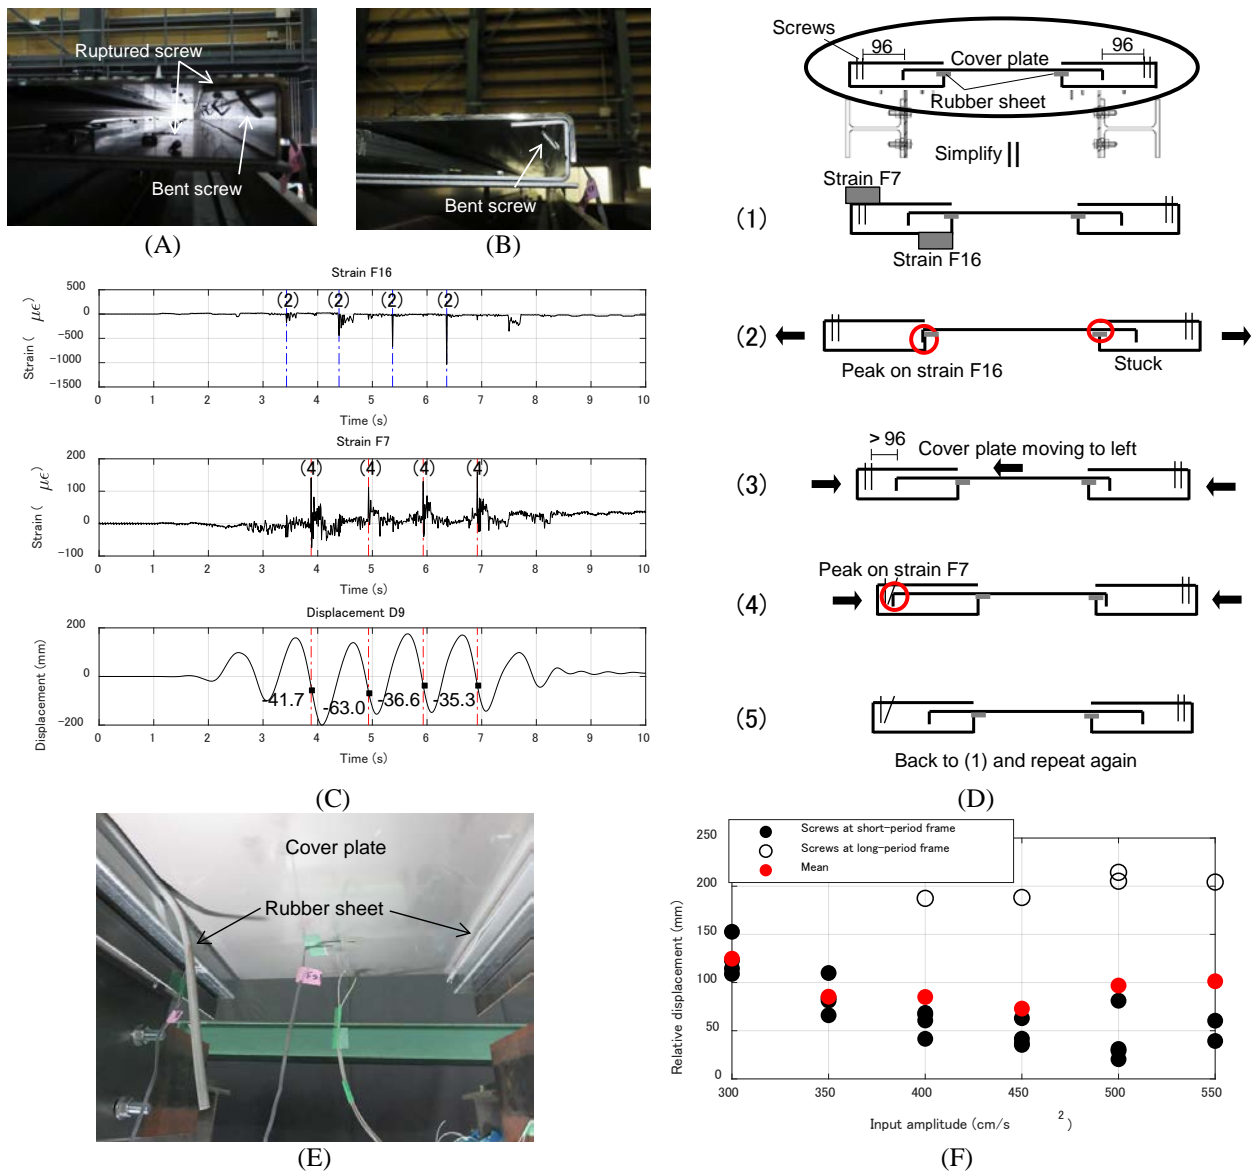
In the SD floor expansion joint specimen, the first observed damage was the fracture of several drill screws, as shown in Figure 15(A)-(B). In the design drawing in Figure 15(D), the distance between the edge of the cover plate and the screws is 9.6 cm. Under the input of 300 cm/s² or larger, the cover plate hit the screws, resulting in bending and fracture of the screws. Under the input of 450 cm/s², five of twenty screws were shear fractured. Four more screws were shear fractured under the input of 500 cm/s². Damaged screws can be easily replaced from above the cover plate and thus this damage was considered damage state 1.

The sequence of the damage during the input of 450 cm/s² is described in Figure 15(D). Ideally, a collision between the cover plate and screws should occur at a relative displacement of $9.6 \times 2 = 19.2$ cm. However, in the experiment, the cover plate moved toward one side due to the imbalanced friction force between the cover plate and the two rubber sheets, and the collision occurred at less than 19.2 cm. For example, under the 450 cm/s², the cover plate collided with the screws on the short-period frame side only. The collisions at (2) in Figure 15(D) represent peaks at strain gauge F16 in Figure 15(C). Assuming that the timing of the collisions at (4) in Figure 15(D) correspond to peaks at strain gauge F7 attached close to the screws, there were four collisions (double-checked by videos). From Figure 15(C), the relative displacements at the moment of these collisions were measured as 4.2 cm, 6.3 cm, 3.7 cm and 3.5 cm in the compression side. Due to the repetition of those collisions, the screws ultimately fractured. After repeated loadings, the rubber sheet was also disengaged as shown in Figure 15(E), and the friction force between the cover plate and rubber sheet differed between the short-period and long-period frame sides.

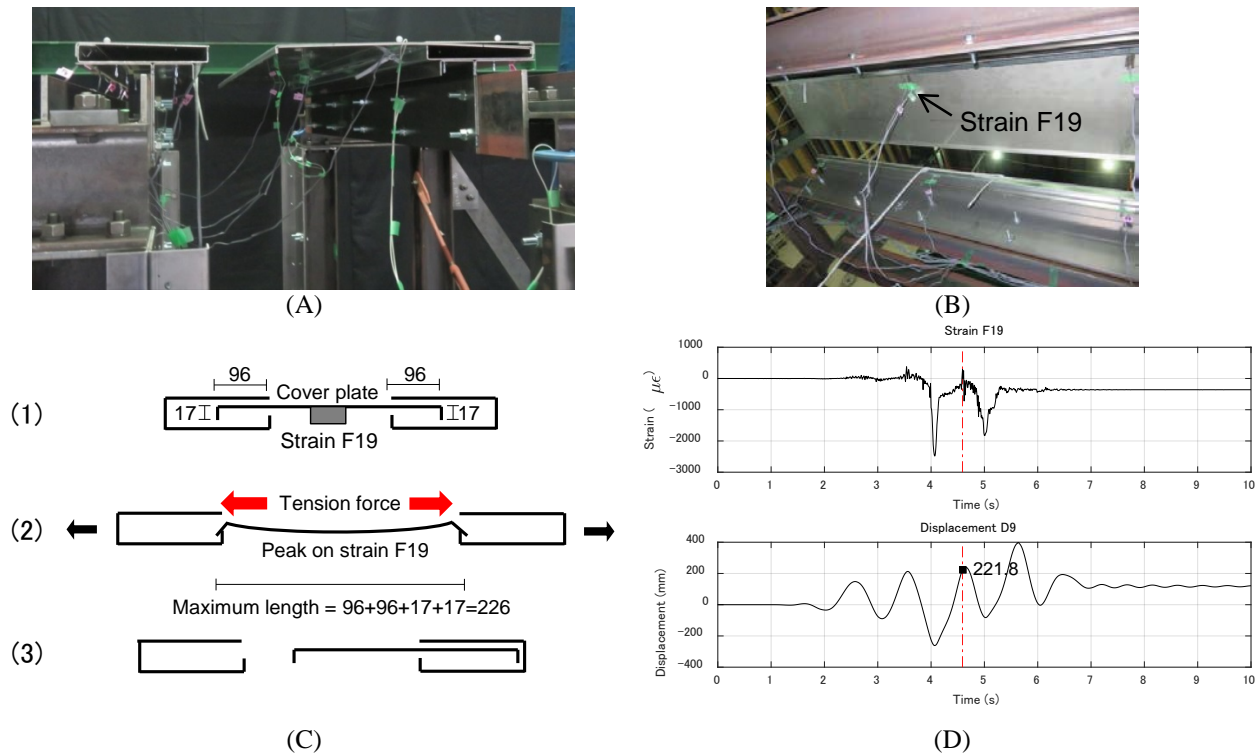
FIGURE 16 SD floor specimen failure (cover plate disengaged) (unit: mm): (A) front view, (B) inside view, (C) damage sequence, and (D) strain and relative displacement response during the excitation of 550 cm/s^2

Figure 16(A)-(B) illustrates the failure mode of the SD floor expansion joint specimen. During the input of 550 cm/s^2 , the cover plate was disengaged from the side plate, creating a gap between floors. Since the cover plate could no longer sustain human weight, its function was lost. Therefore, this damage state was classified as failure. The relative displacement at the timing of failure can be estimated by the response of the strain gauge attached to the cover plate. A large tension force was applied to the cover plate at the moment of failure, as shown in Figure 16(C). From the response of strain gauge F19 attached to the center of the cover plate, this moment was identified as 4.59 s, as shown in Figure 16(D). Note that large peaks in the compression side were observed at F19 due to the cover plate collision with the side plate. From the relative displacement obtained by the D9 transducer, the critical value was calculated as 22.2 cm (127% of the design motion range 17.5 cm). This value is similar to the maximum affordable length of 22.6 cm calculated from the dimension of the cover plate, as shown in Figure 16(C). Therefore, this damage depends on the dimension of the cover plate and is displacement sensitive. In summary, damage state 1 was observed when the relative displacement reached nearly one half of the design tolerance, and the failure occurred at approximately 130% of the design tolerance. Compared to the HP floor expansion joint specimen, which exhibited damage state 1 at 193% of the design tolerance, the margin of safety of the SD floor expansion joint is significantly smaller.

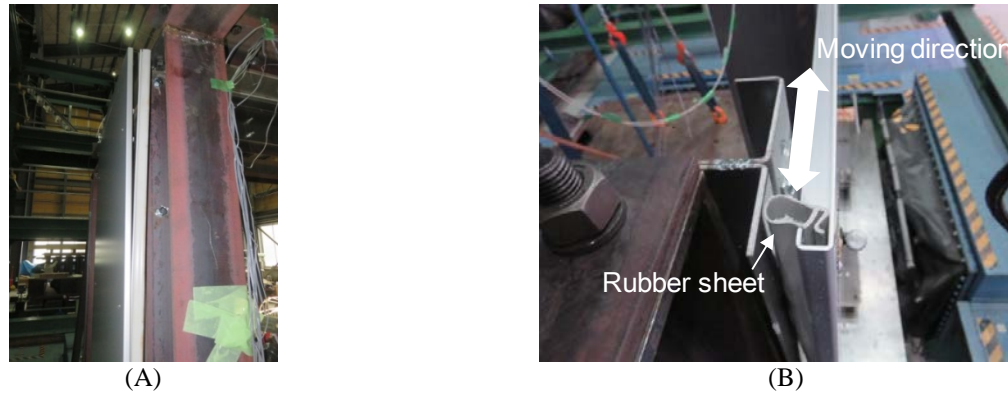
FIGURE 17 SD wall specimen DS1 (rubber sheet disengagement): (A) gap and (B) deformed rubber sheet

Damage state 1 for the SD wall expansion joint specimen was rubber sheet disengagement, as shown in Figure 17. The gap indicated in Figure 17(A) led to concern about air and water leakage. This damage was first observed after the input of 400 cm/s^2 . For each wall expansion joint, two rubber sheets at the edges were attached as a sealing material. During excitations, a rubber sheet on one side moved along with the cover plate and was rubbed by the surrounding materials as shown in Figure 17(B). Under 400 cm/s^2 , the rubber sheet on the back wall was largely detached, and a gap of approximately 5 cm was created. This damage resulted from repeated loading during shakings, and therefore it is difficult to identify the critical demand value that initiates this damage. This damage can be repaired by an adjustment and thus was classified as damage state 1.

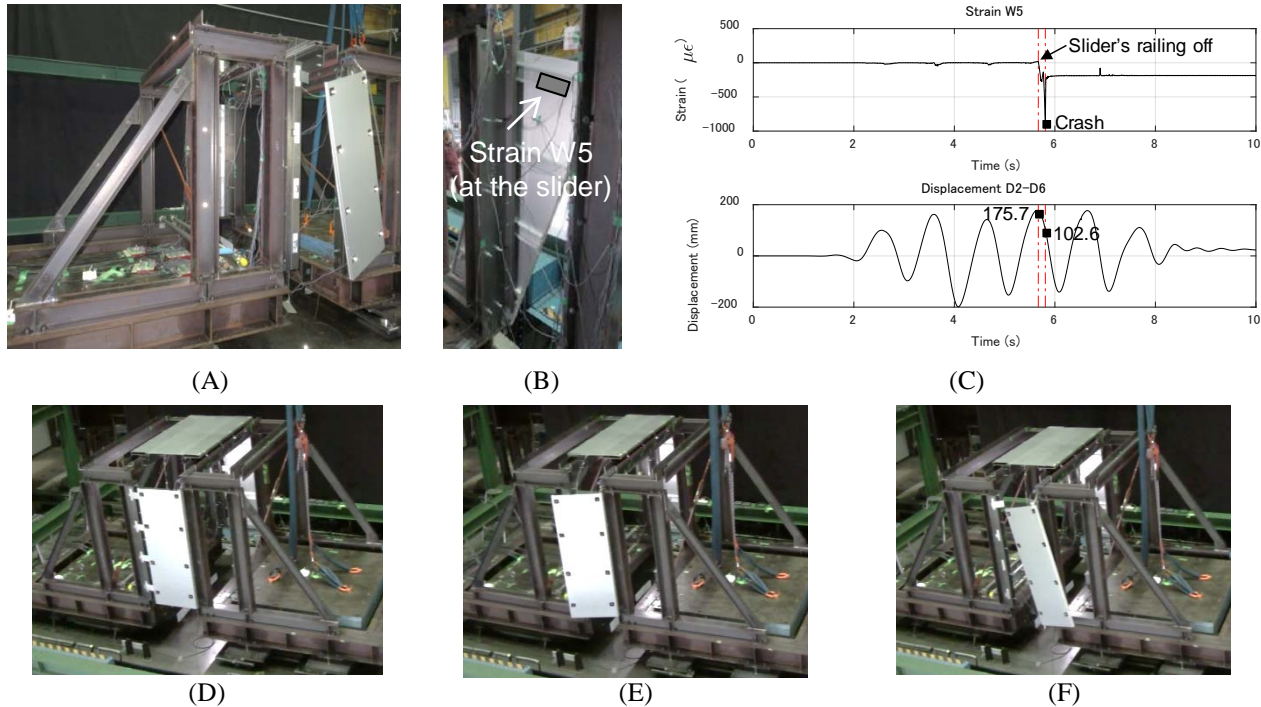
Figures 18(A)-(B) show the failure of the SD wall expansion joint specimen. During the input of 450 cm/s^2 , the cover plate of the front wall fell off because its sliders railed off. Immediately after the sliders dropped off, the short-period frame crashed into the cover plate (Figure 18(D)-(F)). This damage sequence can be explained from the strain responses. As shown in Figure 18(C), the response of the strain gauge W5 attached to the slider had a large peak in the compression side. The large compression force was applied when the cover plate was crashed by the short-period frame, and thus the moment at which the sliders railed off should be at the peak in the tension side immediately before the crash. Therefore, the relative displacement at the time of falling was evaluated as 17.6 cm. This result corresponds well with the design motion range, which was defined as a slider length of 17.5 cm. Thus, this damage state was displacement sensitive. Note that under the excitation of 450 cm/s^2 , only the cover plate of the front wall dropped off because the relative displacement at the back wall was smaller than that at the front wall due to the rotational movement of the long-period frame.

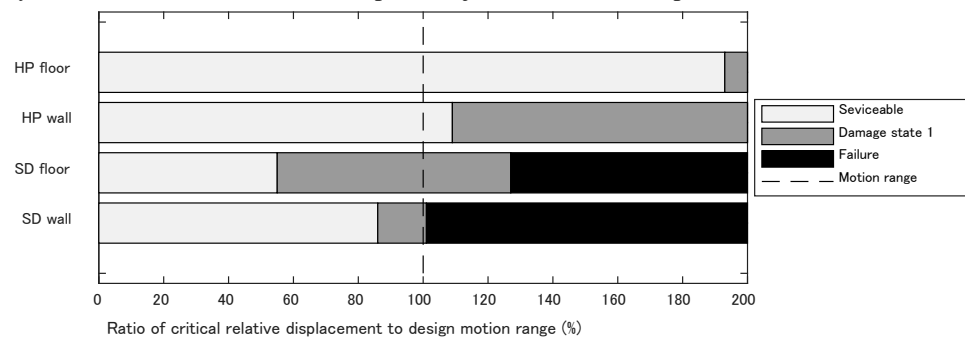
FIGURE 19 Relationship between the damage states and the ratio of the critical relative displacement to the design motion range

The relationship between the damage states and the ratio to the design motion range is summarized in Figure 19. The differences in the safety margin beyond the design motion range of the HP and SD expansion joints specimen are significant. The HP expansion joint specimens exhibited only damage state 1 within 200% of the motion range, whereas the SD expansion

joints showed damage state 1 within the motion range and failure at approximately 100% to 130%. Because the safety margin of the HP specimens was sufficient, this section mainly focuses on the SD specimens. Note that “DS1: rubber sheet disengaged” of the SD wall was not dependent on displacement, but the maximum relative displacement under the input of 350 cm/s² was used here because this damage was first observed after 400 cm/s².

Between the SD floor and wall expansion joints, the margin of failure beyond the motion range differed because the design motion range of 17.5 cm is a nominal value that depends on the manufacturer. The motion range can be easily identified from the drawing for some expansion joints (for the SD wall) but not for others (for the HP floor). Some other motion ranges are determined by the critical length, i.e., the collision length, plus a safety margin (for the HP wall and SD floor). Thus, the safety margin considered in the design motion range differs by manufacturer and type. For the SD wall expansion joint, the safety margin was zero, and failure occurred immediately after the motion range.

Manufacturers should include at least some extent of safety margin in the nominal motion range, especially for expansion joints that are difficult to repair and whose damage may hurt people on the ground, such as wall expansion joints. For example, as seen in the tested SD floor expansion joint, a safety margin of at least 30% beyond the motion range is recommended to guarantee the performance expected from the drawing.

In addition, in the selection of expansion joints, some safety factors (i.e., clearance = minimum separation distance × safety factor) are considered voluntarily by structural designers. To consider appropriate safety factors, the designer should carefully check the deformation mechanism in the drawing and evaluate the amount of safety margin assumed in the nominal motion range set by the expansion joint manufacturers. If there is no safety margin in the nominal motion range, as is the case for the SD wall expansion joint, or no information is available, the designers should consider extending the clearance by a sufficient safety factor to guarantee the motion range of expansion joints for the targeted hazard level. The above statement can be applied when expansion joints are used at a sky bridge connecting adjacent buildings or at a pedestrian bridge. If adjacent buildings are directly connected by expansion joints at a dense city area, a sufficient large clearance between adjacent buildings might not be easy to achieve and the use of HP expansion joints could be an option.
